TECHNICAL REPORT ARBRL-TR-02476

SCANNING ELECTRON MICROSCOPE
EXAMINATION OF COTTON LINTERS AND WOOD
PULP FIBERS BEFORE AND AFTER NITRATION
AND GUN PROPELLANT MANUFACTURE

US ARMY ARMAMENT RESEARCH AND DEVELOPMENT COMMAND
BALLISTIC RESEARCH LABORATORY
ABERDEEN PROVING GROUND, MARYLAND

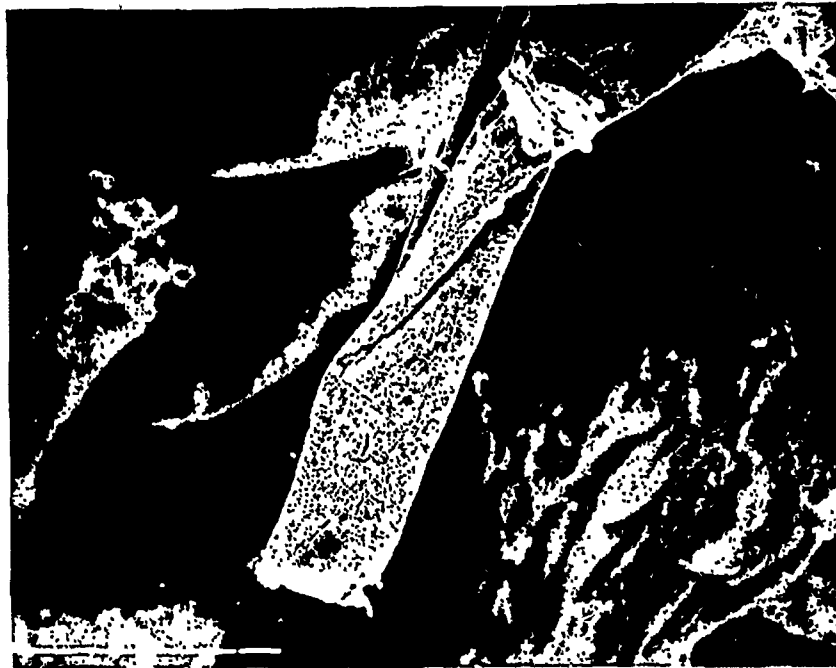
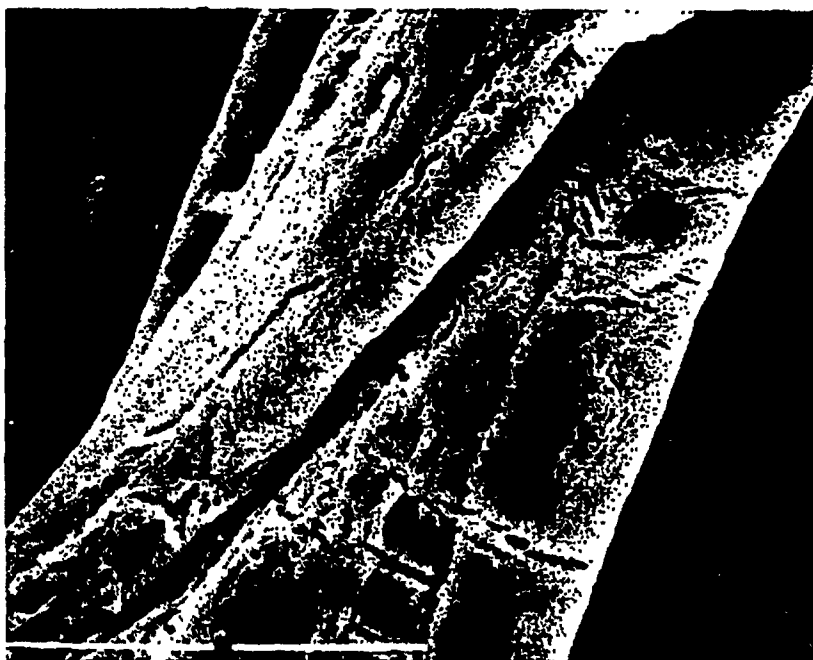
Figure 18. Wood Pulp Nitrocellulose Fibers

Comment: These fibers are from Lot P-1 and show mechanical damage with torn fiber ends, compressed fibers, and small fiber fragments.

2. Wood Pulp Nitrocellulose. All of the wood pulp nitrocellulose fibers appear very similar. These are seen in Figures 16 through 18. The fibers appear to show more mechanical damage than the feedstock, wood pulp cellulose fibers. The nitrocellulose fibers have many broken and torn ends and many short fragments. Many of these fibers appear to have been crushed or severely compressed. The fiber surfaces have numerous cracks and smooth-edged pores. These pores range from 0.05 to 0.3 μm in diameter, with an approximate average diameter of 0.1 μm .

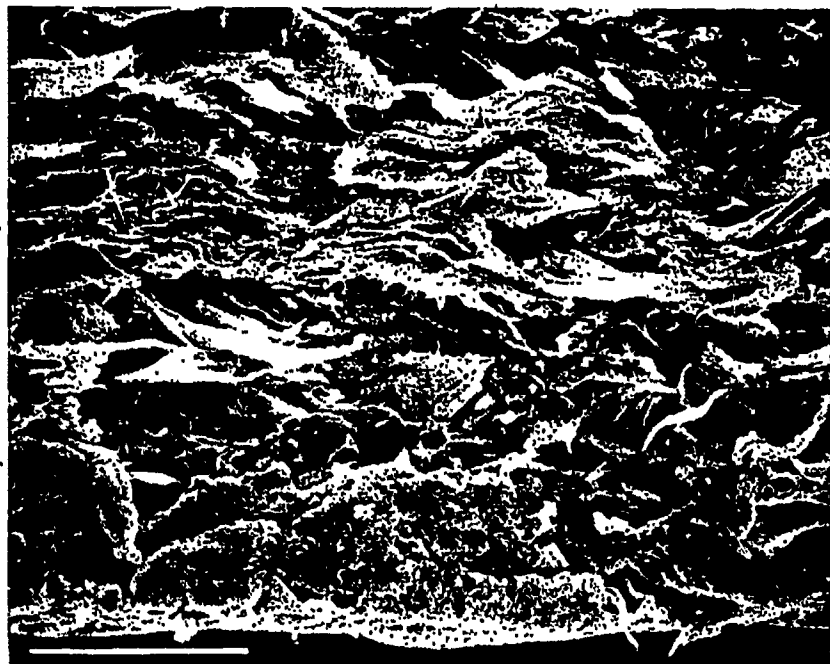
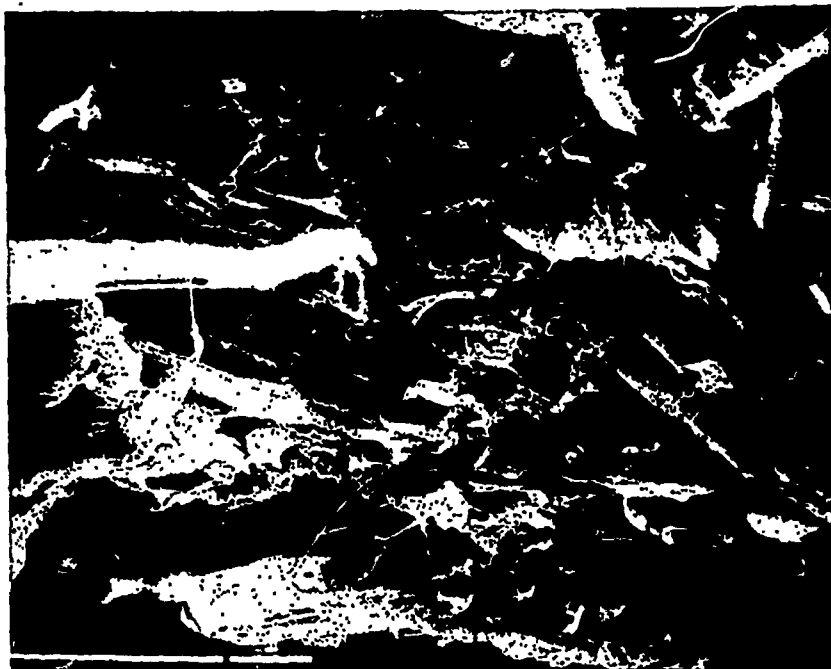
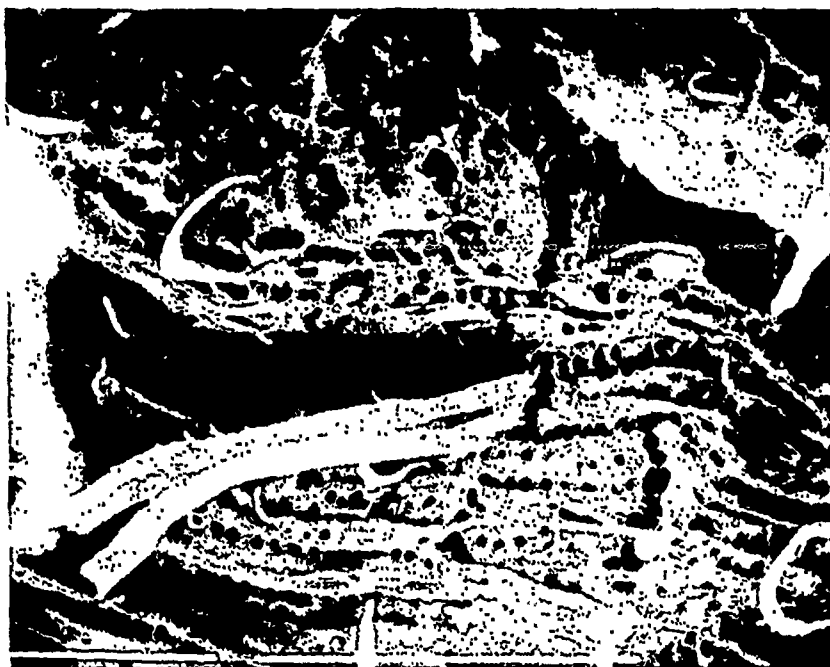
Figure 20. IMR 4350 Single Base Grain Fractured Longitudinally

Comment: Micrograph D is a higher magnification view of the center region of micrograph C. Note that the fibers in the grain are orientated parallel to the direction of extrusion, and parallel to the perforation.

Figures 19 through 23 are of single base extruded gun propellants, IMR 4350 and M10. Figure 19 of IMR 4350 single base propellant is typical of how extruded single, double, and triple base propellants fractured longitudinally (parallel to the direction of extrusion) and latitudinally (perpendicular to the direction of extrusion). The smooth areas on the fractured surfaces are where the knife cut the propellant grain. It can be readily seen that the cut surfaces contain very little morphological information. These smooth regions are very similar to the kind of surfaces produced by microtoming propellant grains.

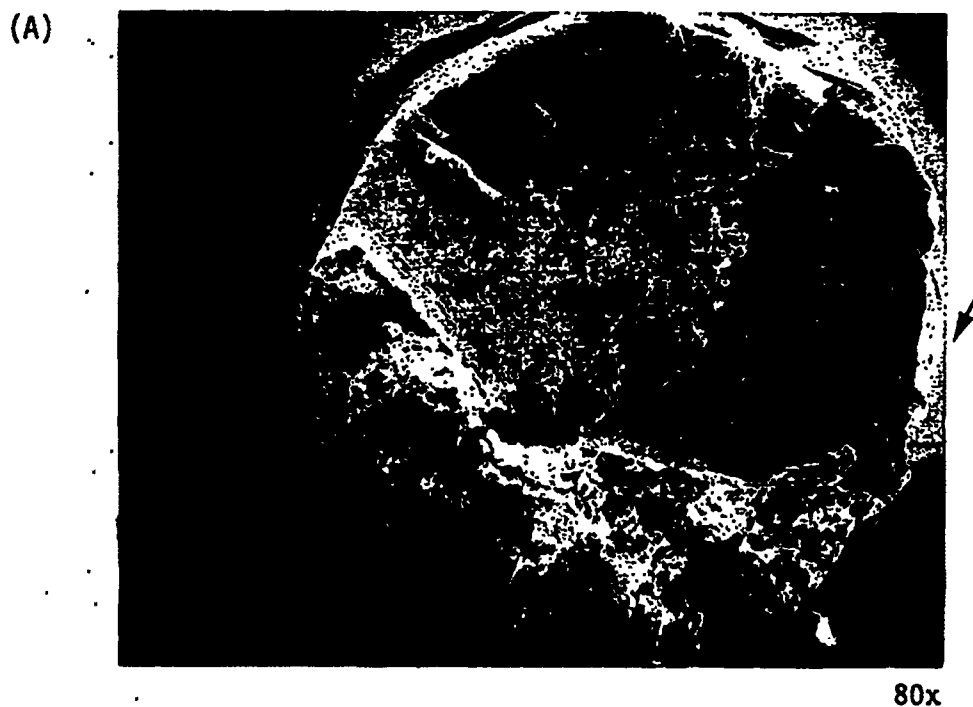
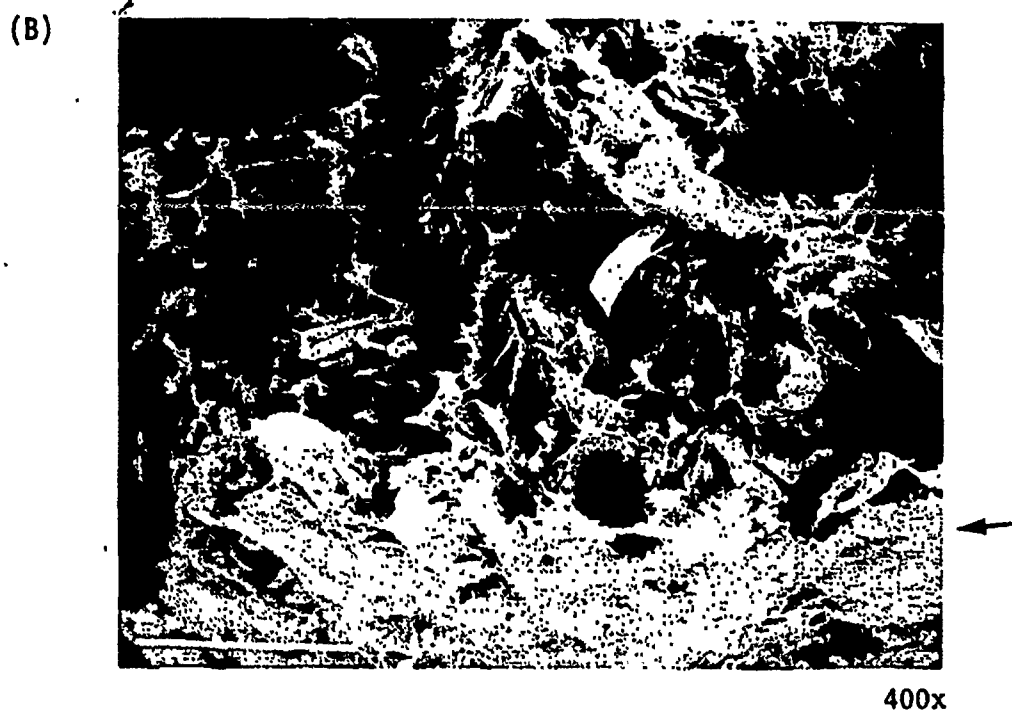
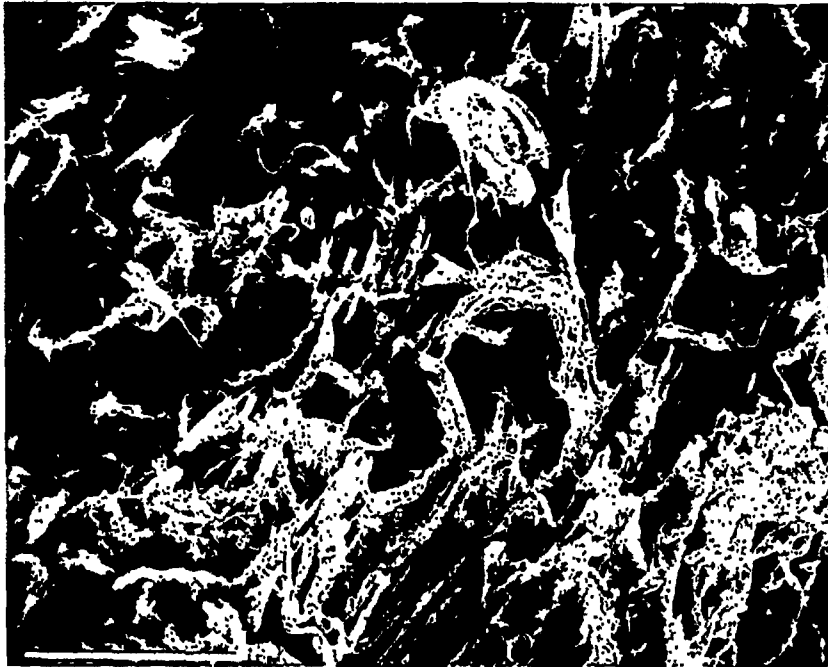
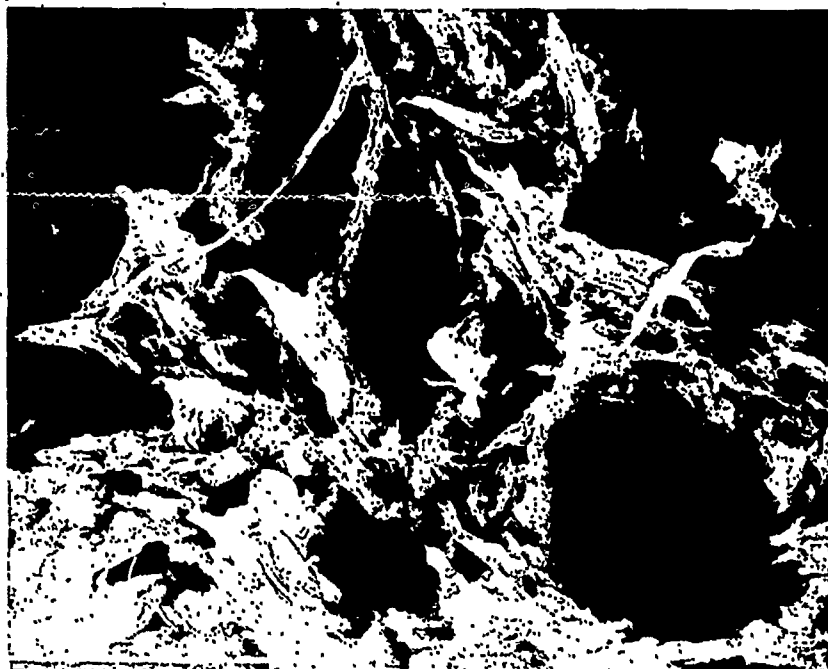
Figure 21. IMR 4350 Single Base Grain Fractured Laterally

Comment: This grain was fractured at room temperature. The arrows indicate the edge of outer grain surface which is graphite coated. Note the orientation of the fibers.

The extruded single, double, and triple base grains fractured like a large wood log. The grains fractured readily longitudinally. The lateral, end view fractures also split like a piece of wood with much splintering at the fractured surface. One would expect a nonfibrous material to fracture like a piece of ceramic rather than like a piece of wood. This behavior suggests that the extruded propellant grains are fibrous, that the fibers are oriented parallel to the direction of extrusion and that the fibers are relatively long in relation to their diameter. Figures 19 through 24, indeed, show the fibrous nature of the nitrocellulose in these typical single base propellants. The original grains were graphite glazed. The M10 propellant also contains graphite in the formulation. Similar single base formulations without graphite in the formulation appear translucent, with color ranging from light green to orange prior to graphite coating.

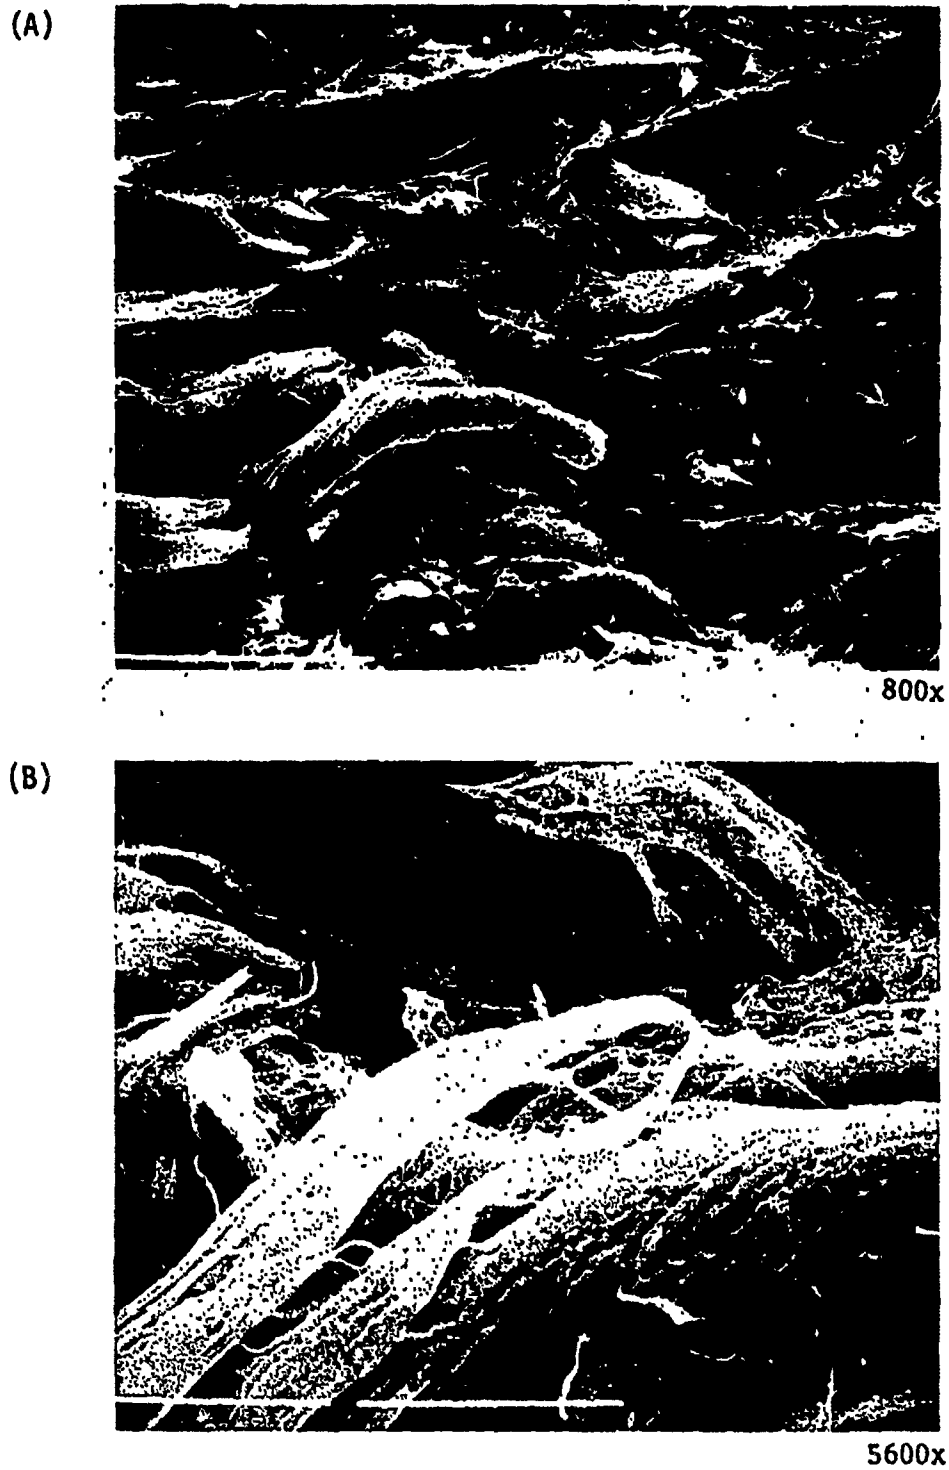
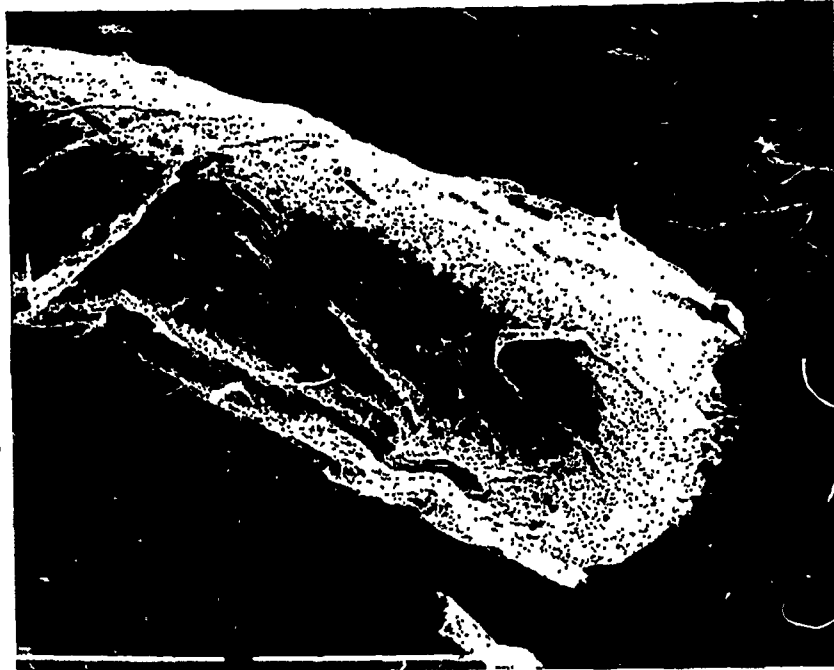
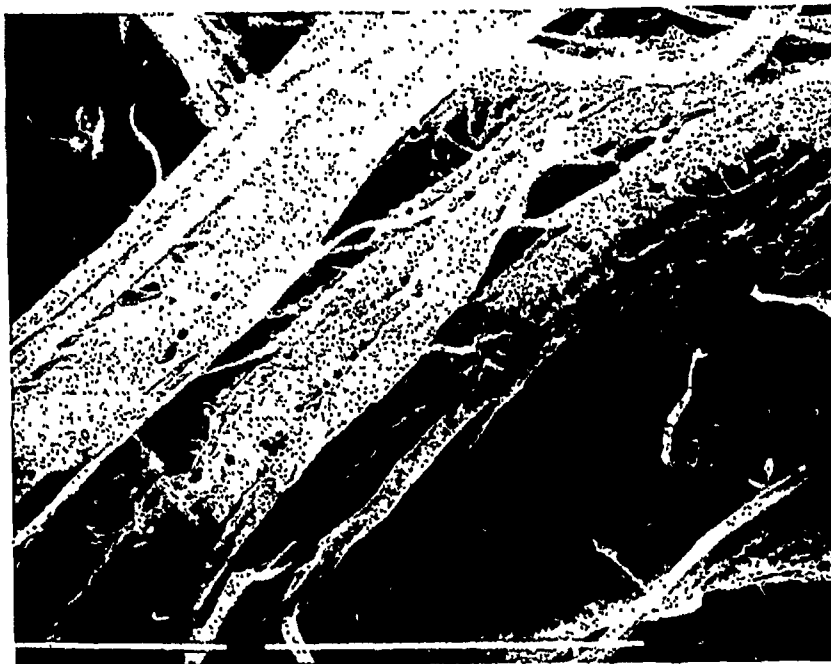
Figure 23. M10 Single Base Grain Fractured in Liquid Nitrogen

Comment: This grain was fractured longitudinally while being immersed in liquid nitrogen. Micrographs B, C, and D are higher magnification views of the intact fiber seen in the center region of micrograph A.

Figure 23 is of an M10 single base propellant grain frozen in liquid nitrogen and then fractured longitudinally. Figure 23(a) shows two cellulose fibers still intact. The remaining micrographs of this figure are higher magnification views of the lower fiber of Figure 23(a). Note the similarity of these micrographs, and, indeed, all of the higher magnification views of single and double base extruded propellants, and magnifications of the cotton and woodpulp nitrocellulose fibers. A general rule is that the higher the nitrogen content of nitrocellulose, the less soluble that nitrocellulose will be. A possible explanation for the observed morphology is that the basic structure appears to be a mat of shredded or unraveled fiber sheets of higher nitrogen content nitrocelluloses. These sheets appear to be delaminated or unwrapped sections of the secondary cell wall structure of the fiber. The two fibers seen in Figure 23(a) are partially delaminated.

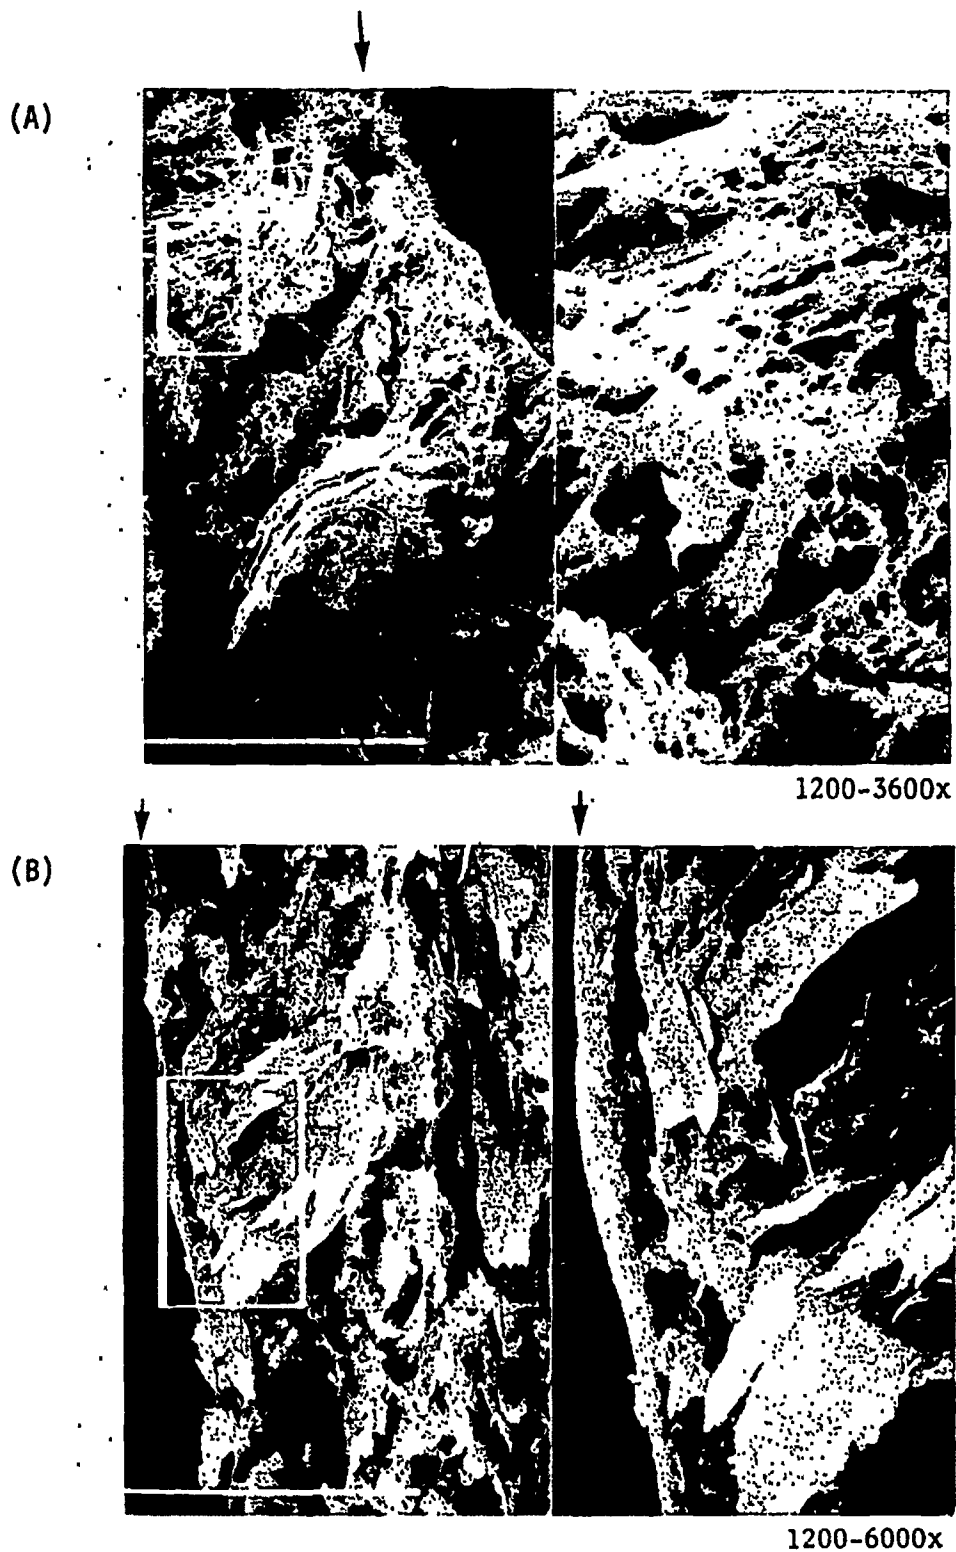
Figure 24. HC25B Extruded Double Base

Comment: These grains were fractured at room temperature. Micrograph A is a longitudinal fracture with the arrow indicating both the direction of extrusion and the outer grain surface. Micrograph B is a lateral fracture with the arrow indicating the edge of the perforation.

The HC25B extruded double base propellant seen in Figure 24 appears very similar to the extruded single base propellant micrographs. The major difference is that the fibrillar structure is less distinct and the nitrocellulose appears to be more solvated. This could be due to the nitroglycerine plasticizer in the formulation. Plasticizers and solvents cause nitrocellulose fibrils to swell. This would make the fibrils less distinct. The nitrocellulose appears fibrous in nature and does not resemble gelatin, but rather a compressed mass of thin, fibrous flakes or sheets.

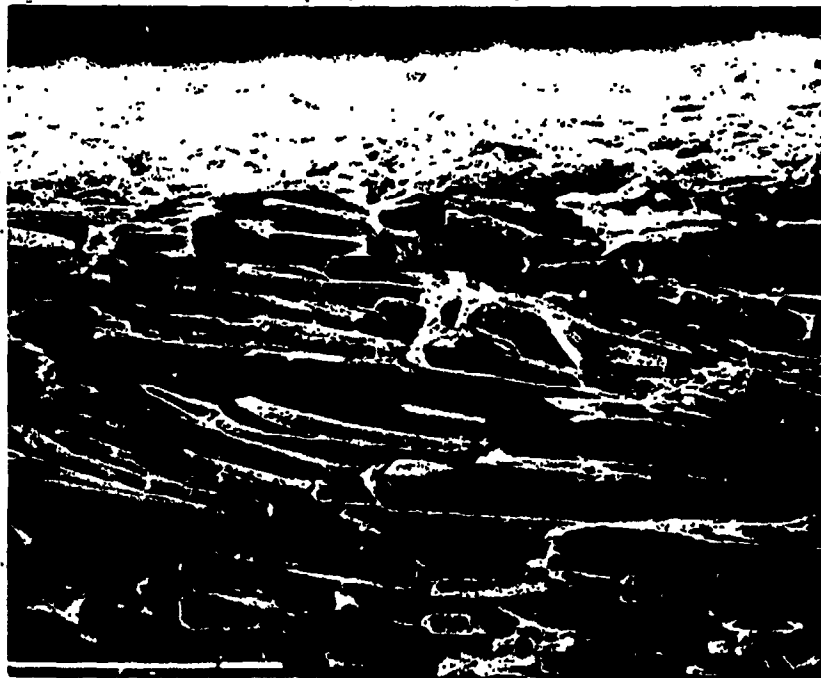
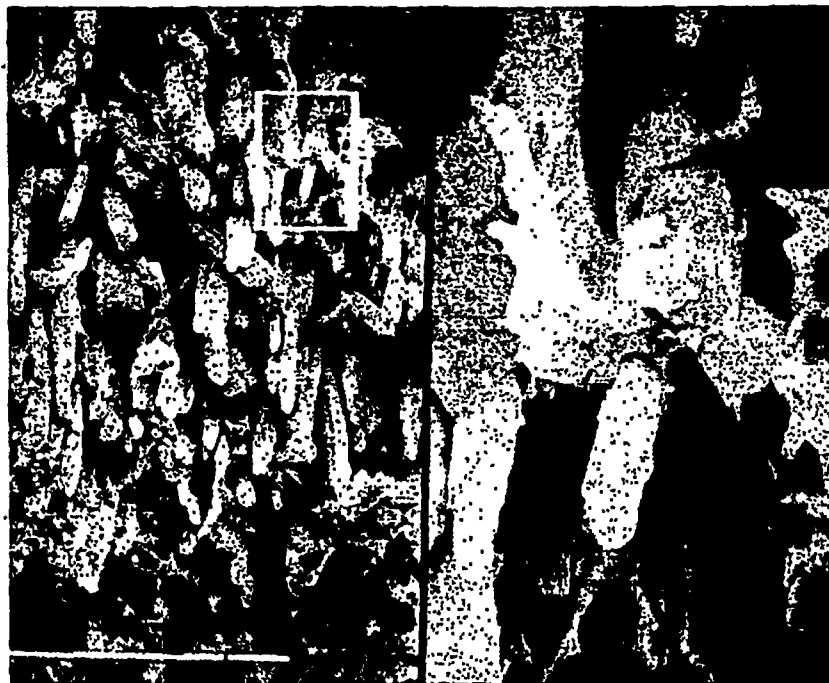
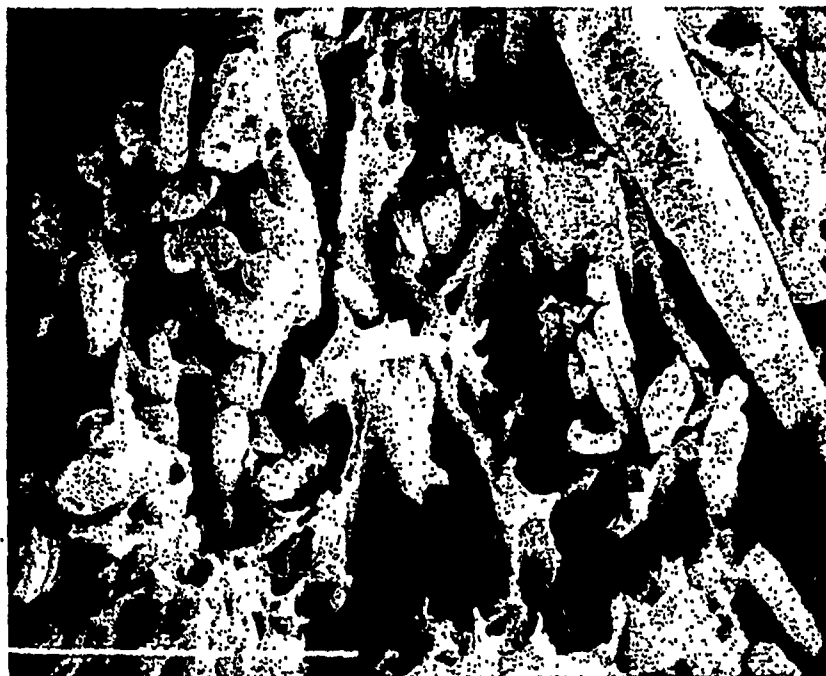
Figure 25. (Cont'd)

Comment: These samples were fractured at room temperature. Micrographs A and B are of the same longitudinally fractured grain surface. The graphite coated exterior surface is visible at the top of each micrograph.

Comment: The nitroguanidine needle-like crystals are parallel to the direction of extrusion which is indicated by the arrow. Micrographs C and D are of two different grains fractured laterally.

The M30A1 triple base propellant in Figure 25 appears markedly different from the single and double base extruded propellants. Figures 25(a) and (b) are longitudinal fractures at the outer edge of the grain. The graphite coating is readily visible at the top of these micrographs. Figures 25(c) and (d) are longitudinal fractured surfaces. The nitroguanidine crystals are oriented parallel to the direction of extrusion and appear roughly cylindrical in shape, with surfaces roughened with small bumps and/or pits. The crystals appear to be separated from each other by a thin layer of nonstructured binder. The nitrocellulose binder appears to be totally solvated, with all of the microfibrillar structure destroyed. Note that the NC used in this propellant contains only 12.6 percent nitrogen. In all of the triple base micrographs viewed, no evidence of the laminar sheets of secondary cell wall or even loose agglomerations of microfibrils has been seen. The original cell wall structure of the nitrocellulose fibers appears to be totally solvated during the mixing process due to the strong solvents and the high percentage of nitroglycerine to nitrocellulose (approximately 40:60) in standard triple base formulations. In the lateral fractures of Figures 25(c) and (d), the nitroguanidine crystals can be seen sticking out from the fracture surface. The holes are the pockets in the binder left by crystals that remained on the other half of the fractured pieces. Each crystal appears to be held in place by a featureless, gelatinous binder with little porosity.

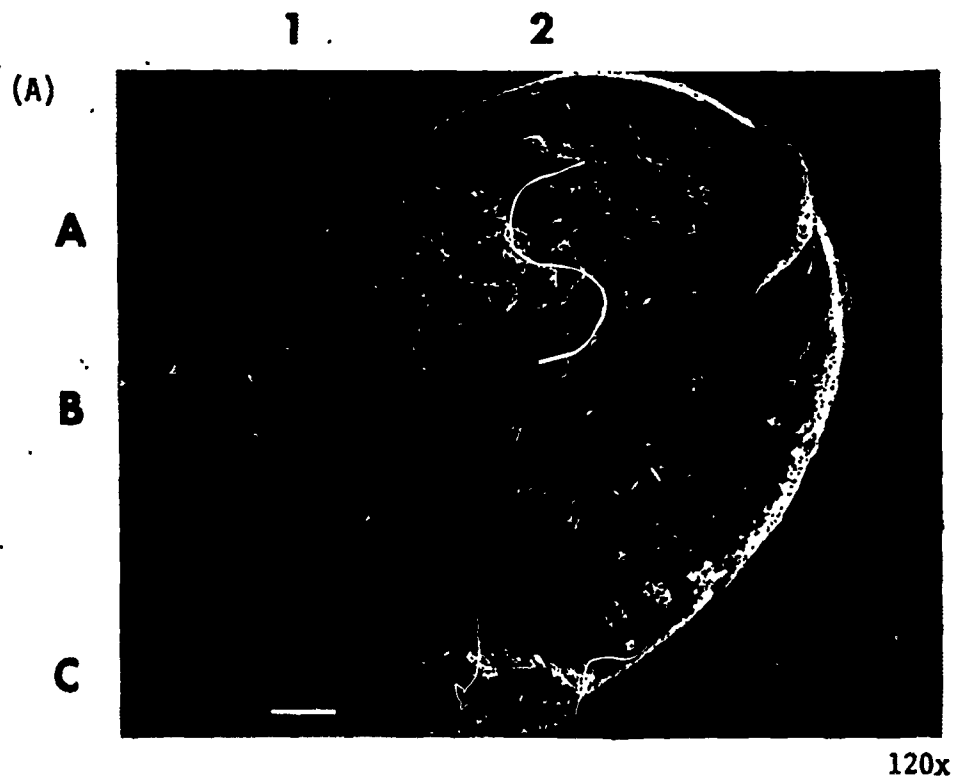
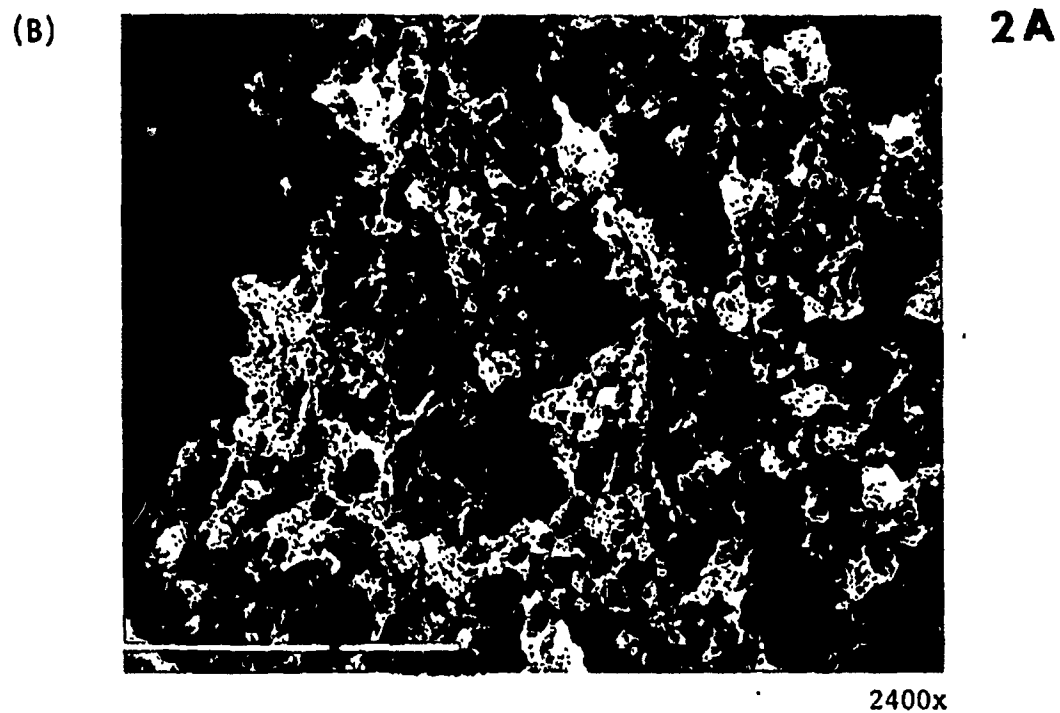
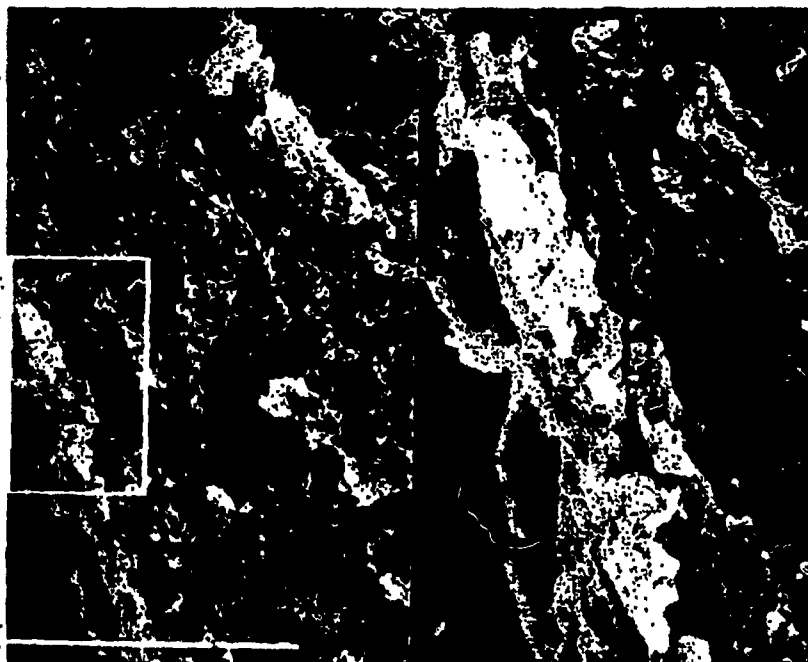
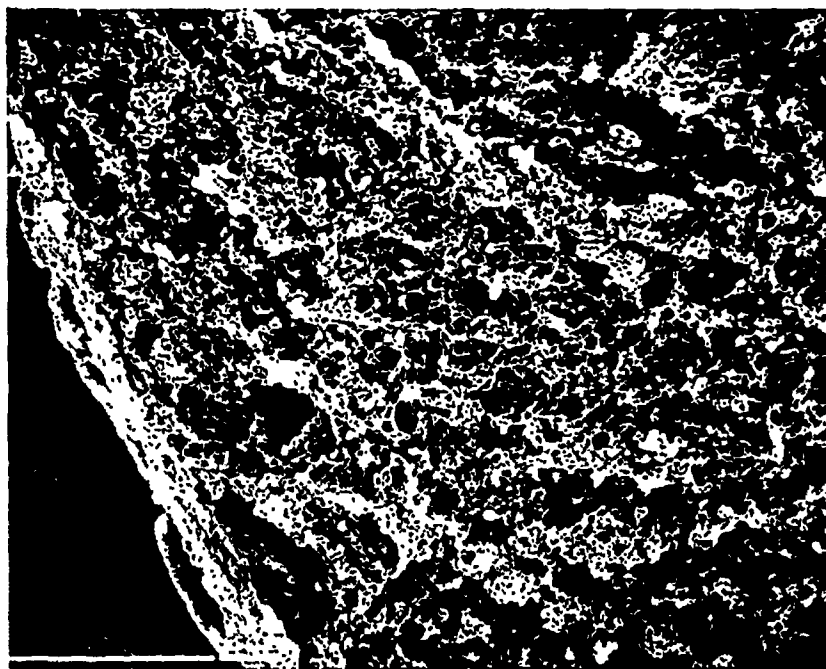
Figure 26. WC870 Double Base Ball Propellant Grain

Comment: All micrographs are of the same grain which was fractured at room temperature. The coordinates on the upper right corner of each micrograph reference the coordinates on micrograph A. Note the wide

Comment (Cont'd): variety of morphologies present on this typical grain. Also note the lack of any fibrous structures in this propellant type.

The double base WC870 ball propellant seen in Figure 26 is made from a much different process than the extruded propellants previously discussed. This propellant is made by totally solvating the nitrocellulose in ethyl acetate. The micrographs show no fibrous structure in the propellant grains. The grains fractured very cleanly, with no splintering and relatively smooth fracture surfaces. Figure 26 shows only a porous
